**CONNECTICUT RIVER BASIN
LUDLOW, MASSACHUSETTS**

**NASH HILL RESERVOIR
MA 00550**

PHASE I INSPECTION REPORT NATIONAL DAM INSPECTION PROGRAM

OCTOBER 1980

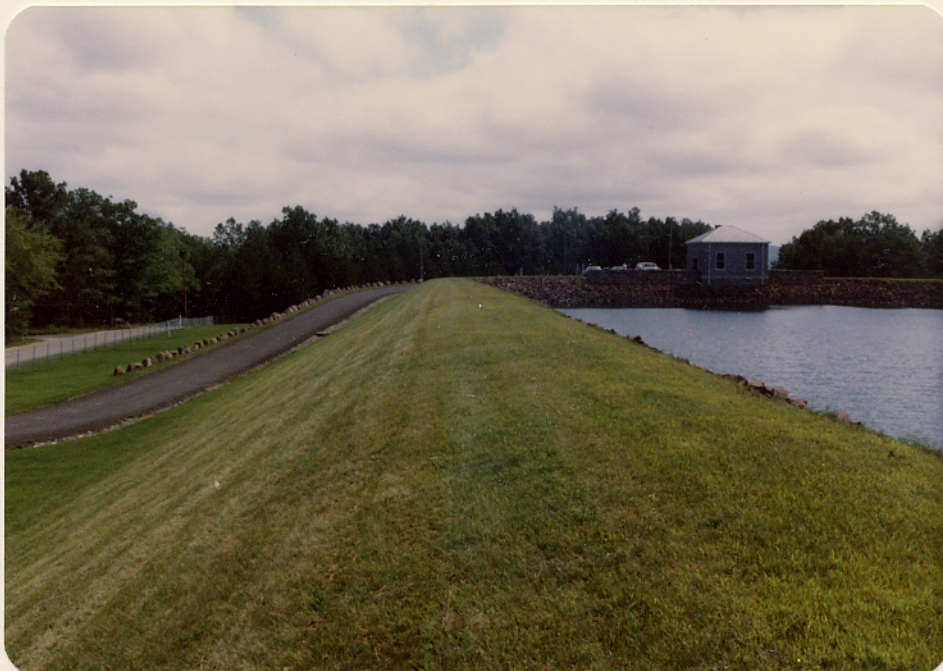
**NO. 1 ACCESS ROAD AND DOWNSTREAM SLOPE OF
EMBANKMENT ON NORTH SIDE OF RESERVOIR**

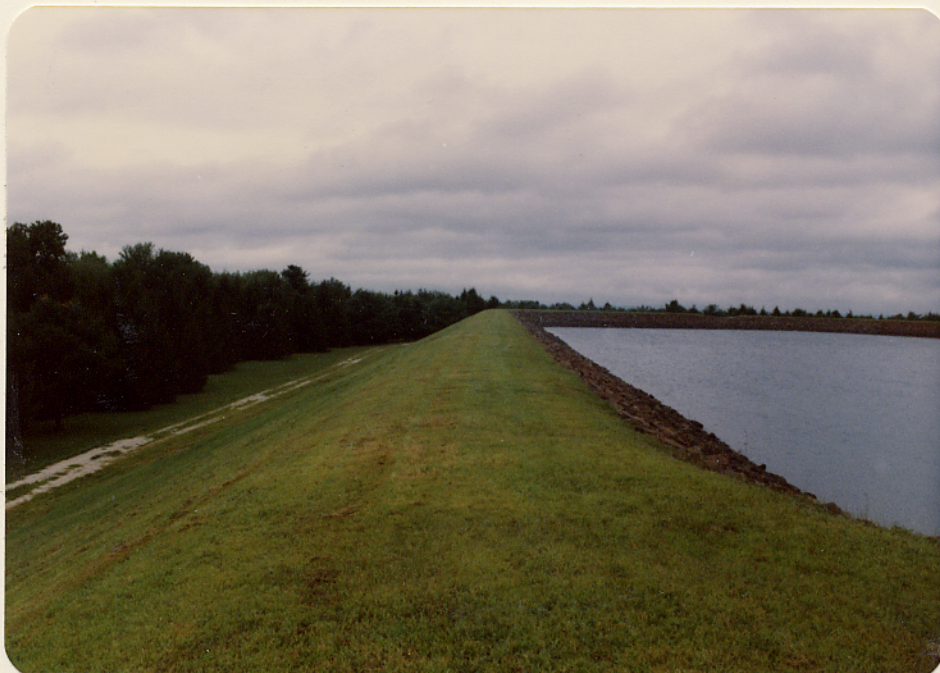
**NO. 2 TOP AND DOWNSTREAM SLOPE OF EMBANKMENT
ON SOUTHEAST SIDE OF RESERVOIR**

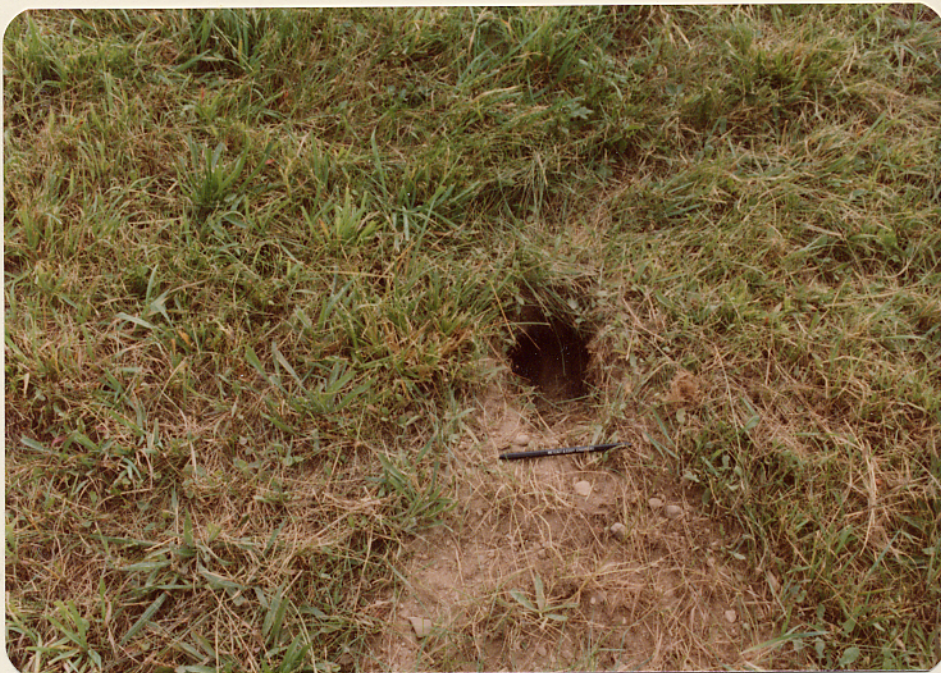
The most notable deficiency at the site is the presence of animal burrows on the top and downstream slope of the embankment. The burrows are 5 inches in diameter and generally about 1 foot deep, but at least two burrows are greater than 3 feet deep (see Photo No. 3). A total of 10 burrows were located, mostly on the southeast, south, and west sides of the reservoir (see Figure B-1). This condition has been cited in previous inspection reports and has reportedly been repaired in the past.

**NO. 3 TYPICAL ANIMAL BURROW ON DOWNSTREAM
SLOPE OF EMBANKMENT**

- a. Operating and Maintenance Procedures. It is recommended that the Owner accomplish the following:
- (1) Backfill all animal burrows on the top and downstream slope of the embankment and continue this procedure on a regular basis whenever new burrows
- NASH HILL RESERVOIR

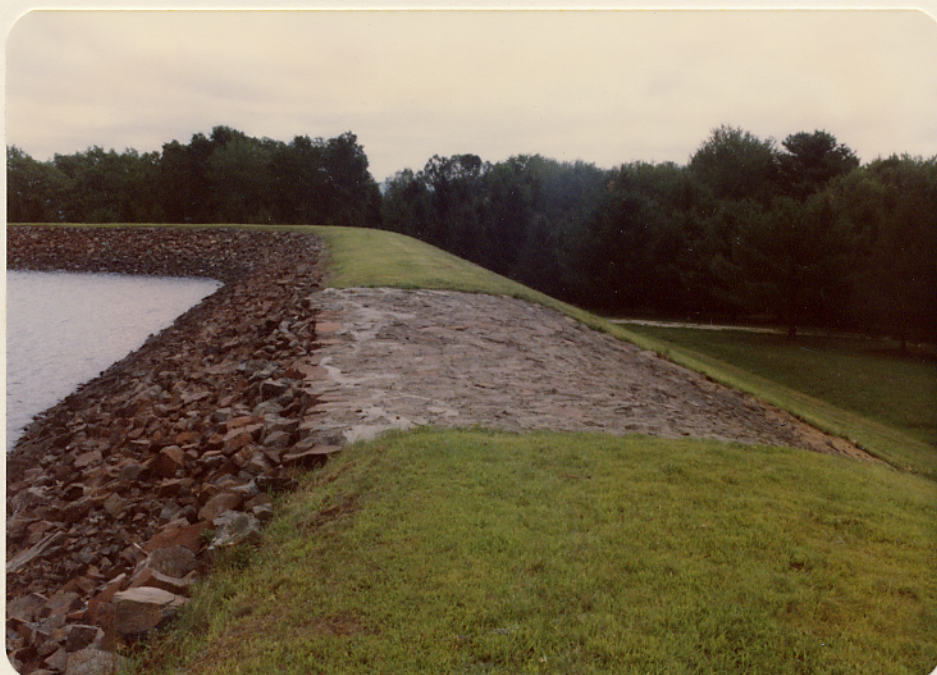
**NO. 4 TOP OF EMBANKMENT AND CREST OF EMERGENCY
SPILLWAY ON SOUTH SIDE OF RESERVOIR**

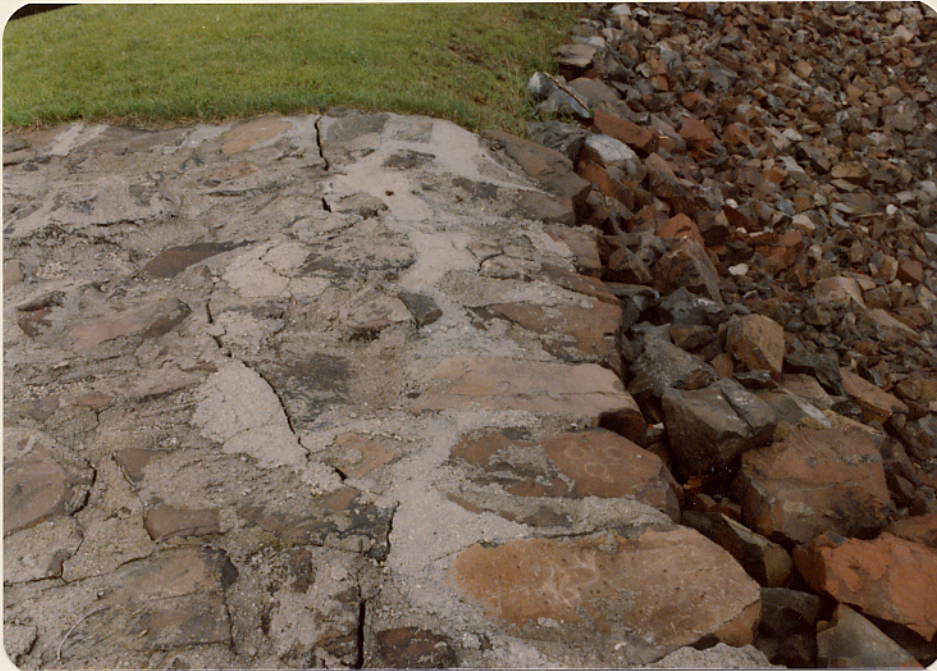
The crest of the emergency spillway is paved with mortared stone. A mortared stone discharge channel from the emergency spillway has been constructed on the downstream slope and toe of the embankment. There are several cracks in the mortar on the crest near the upstream edge. The cracks are oriented lengthwise, parallel to the centerline of the embankment. There is no visible sloughing of the riprap or undermining of the crest. The discharge channel is in good condition. There is a minor growth of weeds and grass in the channel below the downstream toe.

**NO. 5 REPAIRED AND CRACKED MORTAR ON CREST OF
EMERGENCY SPILLWAY**

- (2) Repair cracked mortar on the crest of the emergency spillway.
- (3) Repair the stone masonry retaining wall adjacent to the south side of the gatehouse.
- (4) Institute a definite plan for surveillance of the embankment during and after periods of heavy rainfall and a plan to warn people in downstream areas in the event of an emergency at the reservoir.
- (5) Continue the program of maintenance inspections.
- (6) Institute a program of technical inspections of this embankment on a biennial basis.

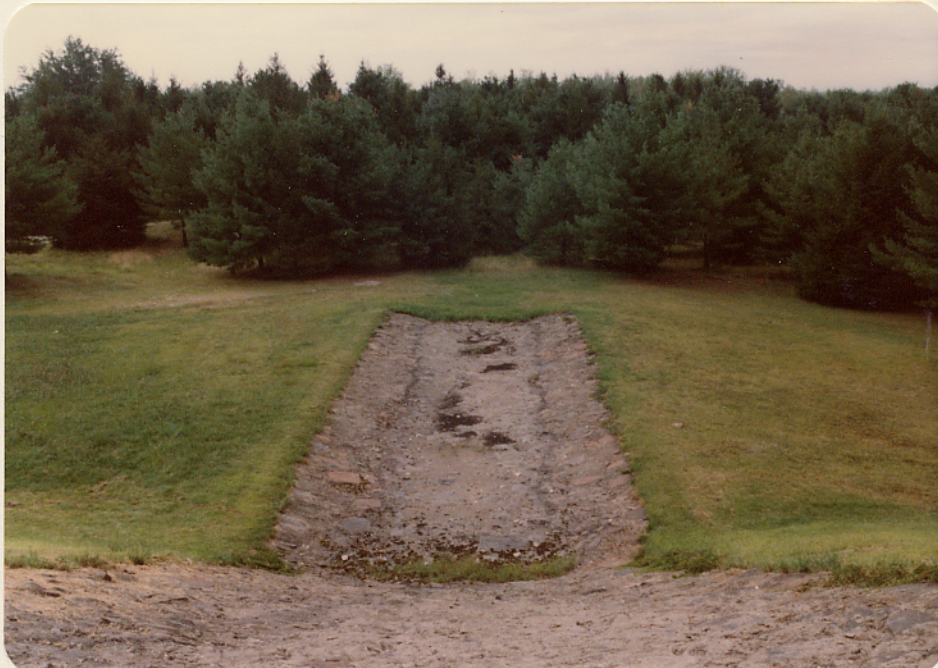
**NO. 6 DISCHARGE CHANNEL BELOW EMERGENCY
SPILLWAY**

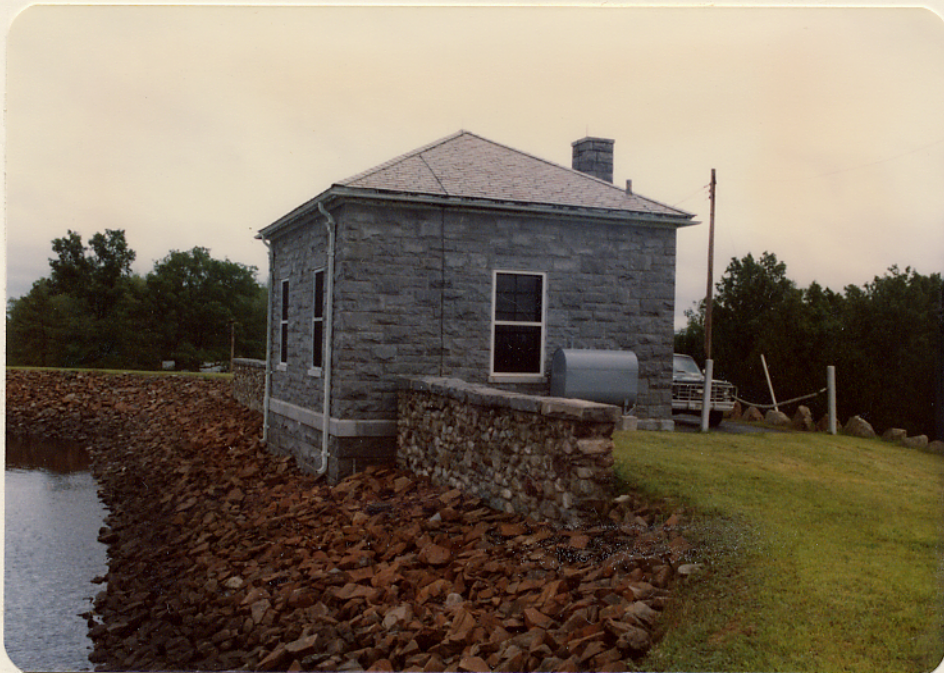
**NO. 7 GATEHOUSE AND UPSTREAM SLOPE OF
EMBANKMENT ON EAST SIDE OF RESERVOIR**

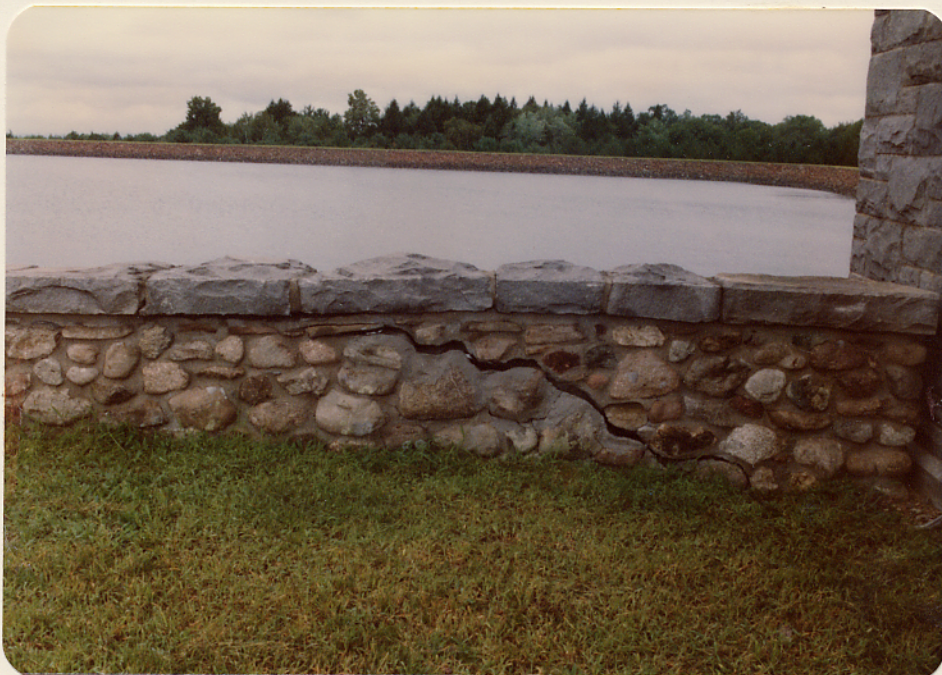
Settlement was observed in the retaining wall at the top of the embankment adjacent to the south side of the gatehouse (see Photo No. 8). A 2-inch wide, 5-foot long diagonal crack has formed in the stone masonry, and vertical displacement is visible in the capstones. However, there is no visible settlement or cracking of the earthfill at the base of the wall.

**NO. 8 SETTLEMENT IN RETAINING WALL ADJACENT TO
GATEHOUSE**
